STRESS CORROSION CRACKING OF TITANIUM ALLOYS

PROGRESS REPORT: JANUARY 1-MARCH 31, 1965

Savannah River Laboratory

STRESS CORROSION CRACKING OF TITANIUM ALLOYS
PROGRESS REPORT: JANUARY 1 - MARCH 31, 1965

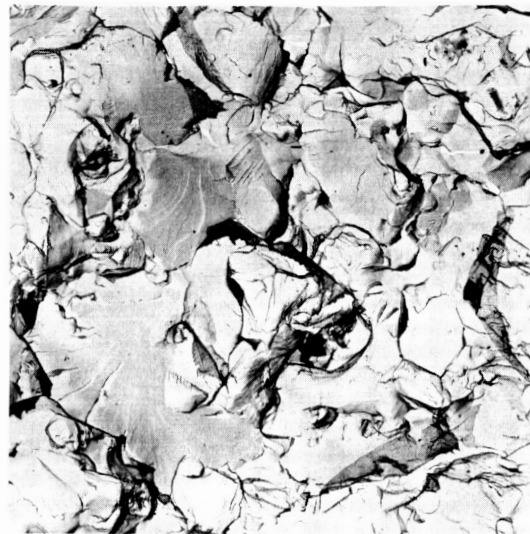
a. Cracks produced by HCl exposures.

b. Cracks produced by NaCl exposures.

FIG. 2 FRACTOGRAPHIC COMPARISON OF CRACKS DEVELOPED IN Ti-8Al-1Mo-1V ALLOY EXPOSED AT 650°F TO ANHYDROUS HCl AND TO NaCl. The surface of the specimen cracked with HCl is clean and shows evidence of cleavage fracture, whereas extensive corrosion is apparent on the surfaces of the cracks induced by NaCl.

The fracture surfaces of cracks produced at 650°F by exposure to HCl gas and to NaCl are compared in Figure 2. The surface of the fracture produced by HCl shows characteristic patterns of mechanical cleavage, whereas corrosion is evident in the NaCl cracks. The latter observation does not preclude the possibility that the corrosion occurred after the cracks had been formed by mechanical rupture of metal embrittled by corrosion-produced hydrogen.

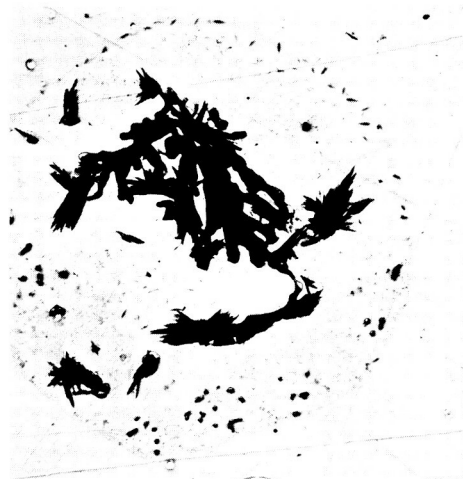
FIG. 6 UNIDENTIFIED PHASE EXTRACTED FROM Ti-8Al-1Mo-1V ALLOY AFTER ATTACK BY NaCl. Note "feathery" appearance of some of the particles. Tentatively indexed as body-centered cubic ($a_0 \sim 5.15 \text{ Å}$).

A corrosion product (Figure 6) was often extracted from the reaction site on the cellulose acetate-carbon replicas used in electron metallography of the samples. This phase was examined by selected area electron diffraction and tentatively indexed as a body-centered cubic structure with a lattice parameter of approximately 5.15 Å. The composition of the phase has not yet been determined. The "feathery" appearance of the extracted phase was quite pronounced in regions having only slight corrosion but was not nearly as apparent and sometimes lacking, in regions where extensive corrosion had occurred. The relationship of the extracted phase to hot-salt cracking has not yet been established.

The same phase was extracted from the fracture faces of samples that were cracked by exposure at 650°F to NaCl and to HCl gas. The amount present was much greater on samples cracked by NaCl; only trace quantities of the phase were found on HCl fracture. This result indicates that this phase was probably not involved in HCl cracking and was produced after the cracks had formed. Efforts are continuing to identify the body-centered cubic phase and determine if it is involved in cracking by NaCl. If so, one possible explanation for the apparent threshold temperature for cracking is that the melting point of the body-centered cubic phase corresponds to the threshold temperature.

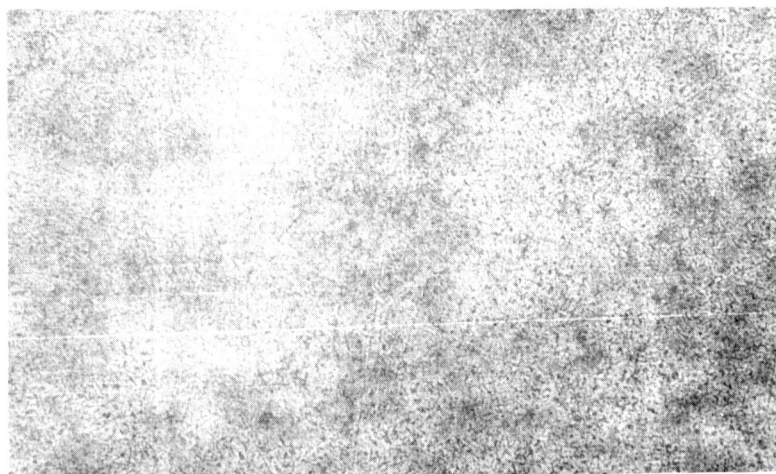
FIG. 8 APPEARANCE OF STRESSED Ti-8Al-1Mo-1V ALLOY EXPOSED TO NaF FOR 14 DAYS AT 650°F. No cracking occurred during exposure. (250X)

Results reported last quarter⁽³⁾ indicated that hot-salt cracking occurred when stressed specimens were exposed at 650°F in three-point-loaded jigs while exposed to NaI and NaBr. These results were confirmed using four-point-loading jigs and with only one type salt exposed in a furnace at a time to avoid possible decrepitation or gas-transfer effects. Identical samples exposed to NaF for 2 weeks did not crack; however, a uniform distribution of tiny pits was observed throughout the sample surface (Figure 8).
